Zlin Aviation s.r.o. Notice of Continued Airworthiness
Safety Alert 090216
Inspection and replacement of cowl door hinge rivets

DATE OF NOTICE: 9 February 2016
EFFECTIVE DATE: Immediately
AFFECTED AIRCRAFT: Zlin Savage, All models with opening engine bay cowl doors
AFFECTED SERIAL NUMBERS: All aircraft with engine bay cowl doors
NOTICE ID: SA090216
PAGES: This is page 1 of 3 pages.

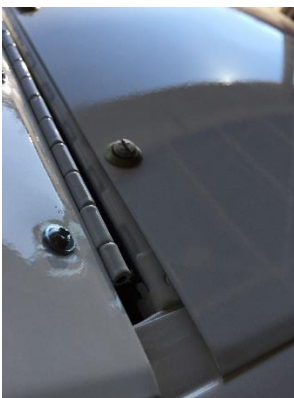
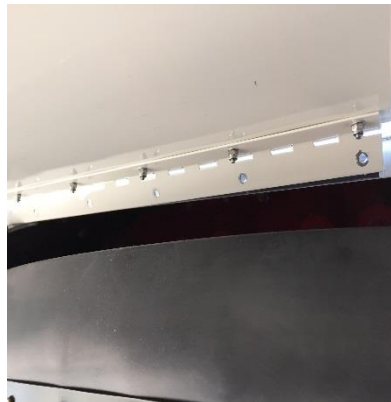
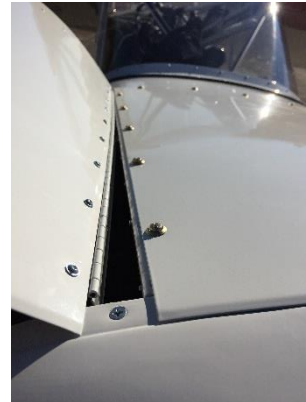
Photo 1

SITUATION: A report from the field indicates that an aircraft cowl became loose at the upper cowl channel hinge attach line but did not depart the aircraft. The aircraft was operating at high power settings for more than two hours without any indication of the issue. Apparently the airflow during cruise kept the cowl door closed. As the aircraft returned to base, in the landing flare, the top of the cowl hinge was observed to be loose at the attachment point of the hinge to the upper cowl structural channel. See photos 1, 2, & 3 below.

The upper forward 10 rivets on the right cowl door hinge failed. The cowl remained attached by the aft two remaining rivets. Aircraft that sustain continued vibration, are located near coastal or salt waters, whether stored inside or parked outside may be more susceptible to corrosion of any metal surfaces or attachments.

CORRECTIVE ACTION: Prior to the next flight and every flight thereafter, the pilot should inspect and carefully examine each rivet in both left and right cowl upper channel attachment lines for any missing or loose rivets. The cowl doors are not affected, nor is the cowl hinge or hinge pin

Within the next 10 hours of operation remove the first (forward) and last (aft) rivet of upper attachment of each cowl hinge to the upper cowl channel. A total of 4 rivets will be removed. Install a protective barrier, cardboard or plastic over the engine cooling fins to prevent any rivet removal debris from lodging in the engine cavities. Re-attach all four previous rivet locations with a single Metric M3x10 screw, install an M3 washer and Nylock M3 nut on the opposite side. A total of 4 screws, 4 washers and 4 nuts are required.

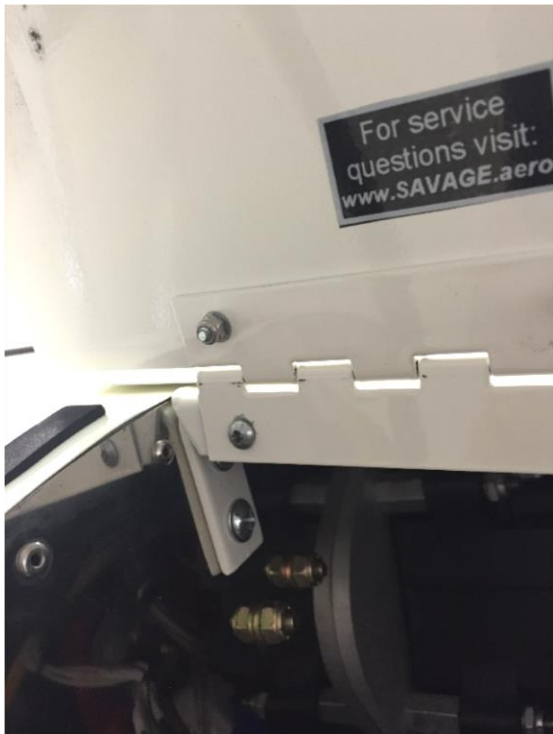
Photo 4: New Right Aft Cowl Attachment

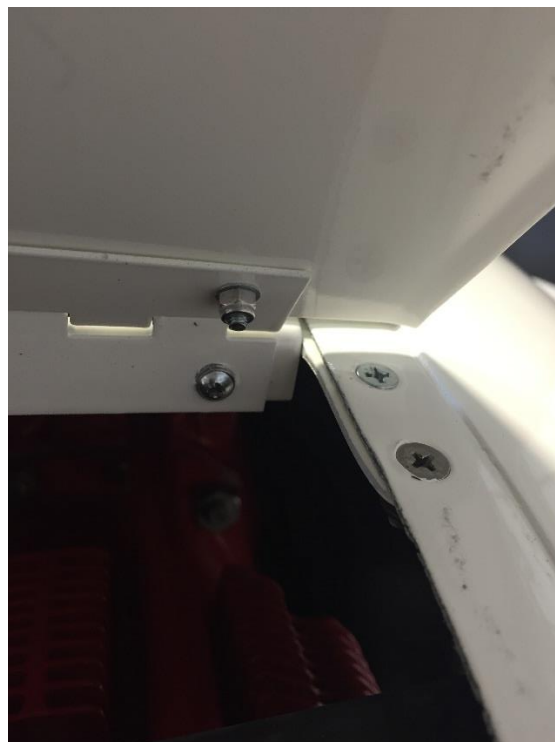
Photo 5: New Right Forward Cowl attachment

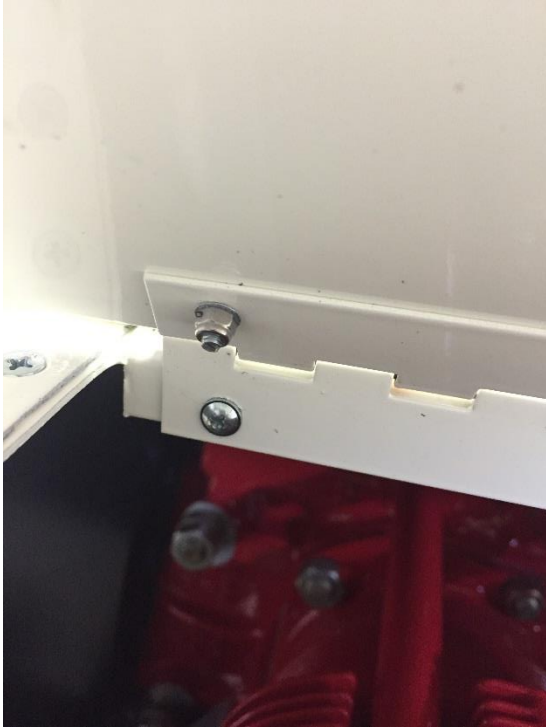
Photo 6: New Left Forward Cowl Attachment

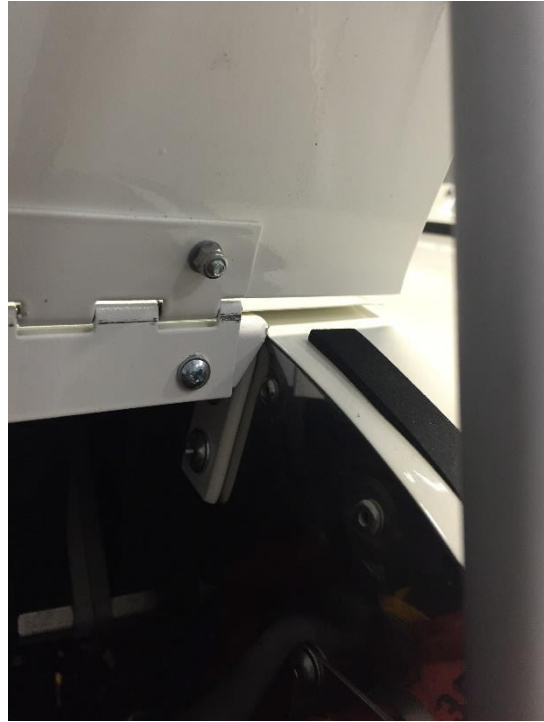
Photo 7: New Left Aft Cowl attachment
