Zlin Aviation s.r.o.

Service Bulletin	N° 2	Date 01/oct/2007
------------------	------	------------------

Check mechanic fuel pump (fig1)

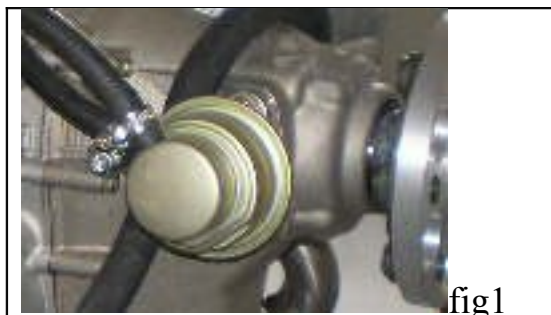
- **Airplanes affected**
All Savage power by Rotax engine
- **Reason**
In one case we found show wear on the mechanic fuel pump caused by camloc's vibration.
- **Subject**
You have to make a visually condition check of the mechanic fuel pump.
If you find abnormal condition send a high resolution picture of this part to mail address: savage.ulm@tiscali.it
After, Zlin Aviation will answer you about the eventually work to do.
