Zlin Aviation S.R.O.

| Safety Alert | N°06 | 24 AUG 2012 |

MANDATORY

visual control of the correct installation of the rudder pedals and brake pedal assembly, and in particular control that the combined action on the rudder pedal and brake pedal to its physical limit cannot incur in a contact between some pedal component and the firewall diagonal tubes.

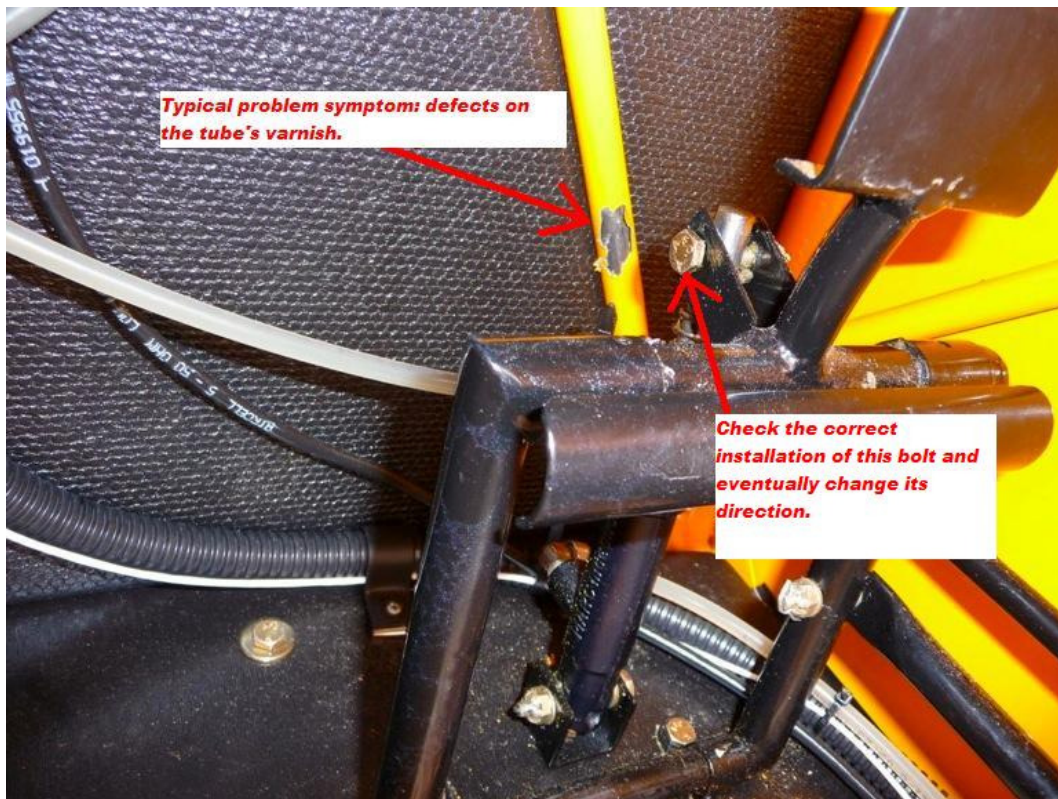
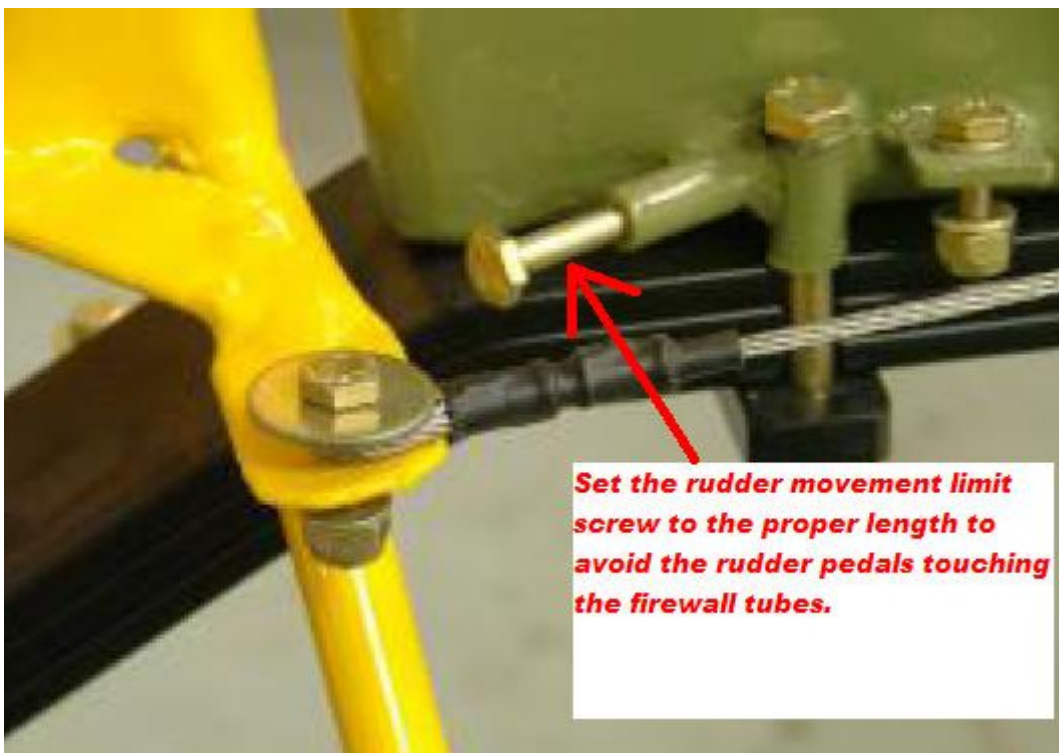
Pictures:

locking of right rudder pedal has been reported in a Savage plane assembled from kit not by Zlin Aviation sro. The event was caused by the upper piston brake screw head or safety nut's contact with the firewall's diagonal tube. The event was solved by the pilot without any kind of consequences.

Note: a normal possible symptom of the problem might be the defect or local lack and removal of varnish on the diagonal firewall tube, due to the friction of the described parts. See picture.

- 1) Check if the paint of the firewall's diagonal tubes presents some defects.
- 2) Simulate the foot action on the rudder to its limit, and then apply brake pressure also to the limit, in both directions, and observe if any contact or friction occurs between some pedal components and the firewall tubes.

In case contact occurs, check the following solutions which might easily avoid the contact and the problem:

- A. Correct mounting direction of the upper screw and safety nut that holds the cylinder brake to the brake pedal, which should be inbound.
 - B. Correct setting of the two limit bolts in the rudder/tail wheel area. Eventually register these bolts in a way that the pedals cannot contact the firewall. The bolts create the stop of the rudder travel so in this way you can adjust the movement of the pedals. See picture.
 - C. Correct angle setting of the rudder pedals in respect to the floor ground, which should be slightly less than 90° (=facing towards the pilot, thus keeping more distance from the firewall).
- 3) If the problem appears, and none of the above checks and settings can solve it, please contact Zlin Aviation s.r.o.
