Zlin Aviation S.R.O.

Safety Alert	N°05	28 JAN 2011
--------------	------	-------------

- **Airplanes affected:**
Savage Aircrafts Serial numbers from 001 to 090.
- **Subject:**
Visual control and eventual removal of disengaged false ribs.
Report immediately (in case of disengagement) to Zlin Aviation sro.for further instructions!
- **Reason:**
Disengagement of some false ribs inside one costumer's wing was reported (see the picture).

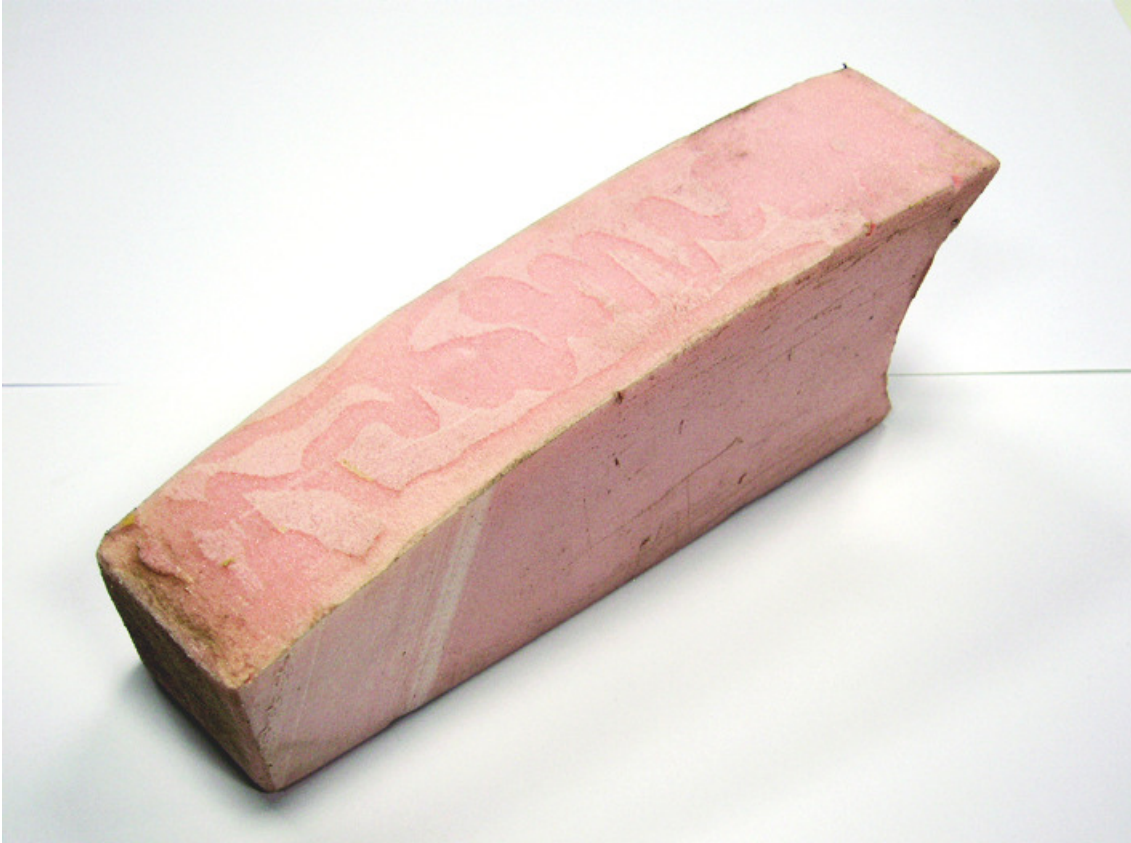
Picture of the false rib:

NOTE: This issue would have been caused by aging of the glue, which was used to fit false ribs to the metal sheet in the main wing spar.

- **Compliance:** Issue date of SA
- **Material required:** Mirror and flashlight.
- **Accomplishment:** There are 9 false ribs in each wings.
 1. Open the inspection plates in the bottom of the wing.
 2. Use mirror and flashlight and look inside the wing for any free disengaged false ribs.
 3. If some disengaged ribs will be found, remove them from the wing.

4. Please contact Zlin Aviation company for further steps in reparation.
